Flood Mitigation Needs Assessment

**Six Mile Creek, Salmon Creek, Fall Creek, & Cayuga Inlet
Tompkins County, New York**

September 2005

Milone & MacBroom, Inc.
99 Realty Drive
Cheshire, CT 06410
(203) 271-1773

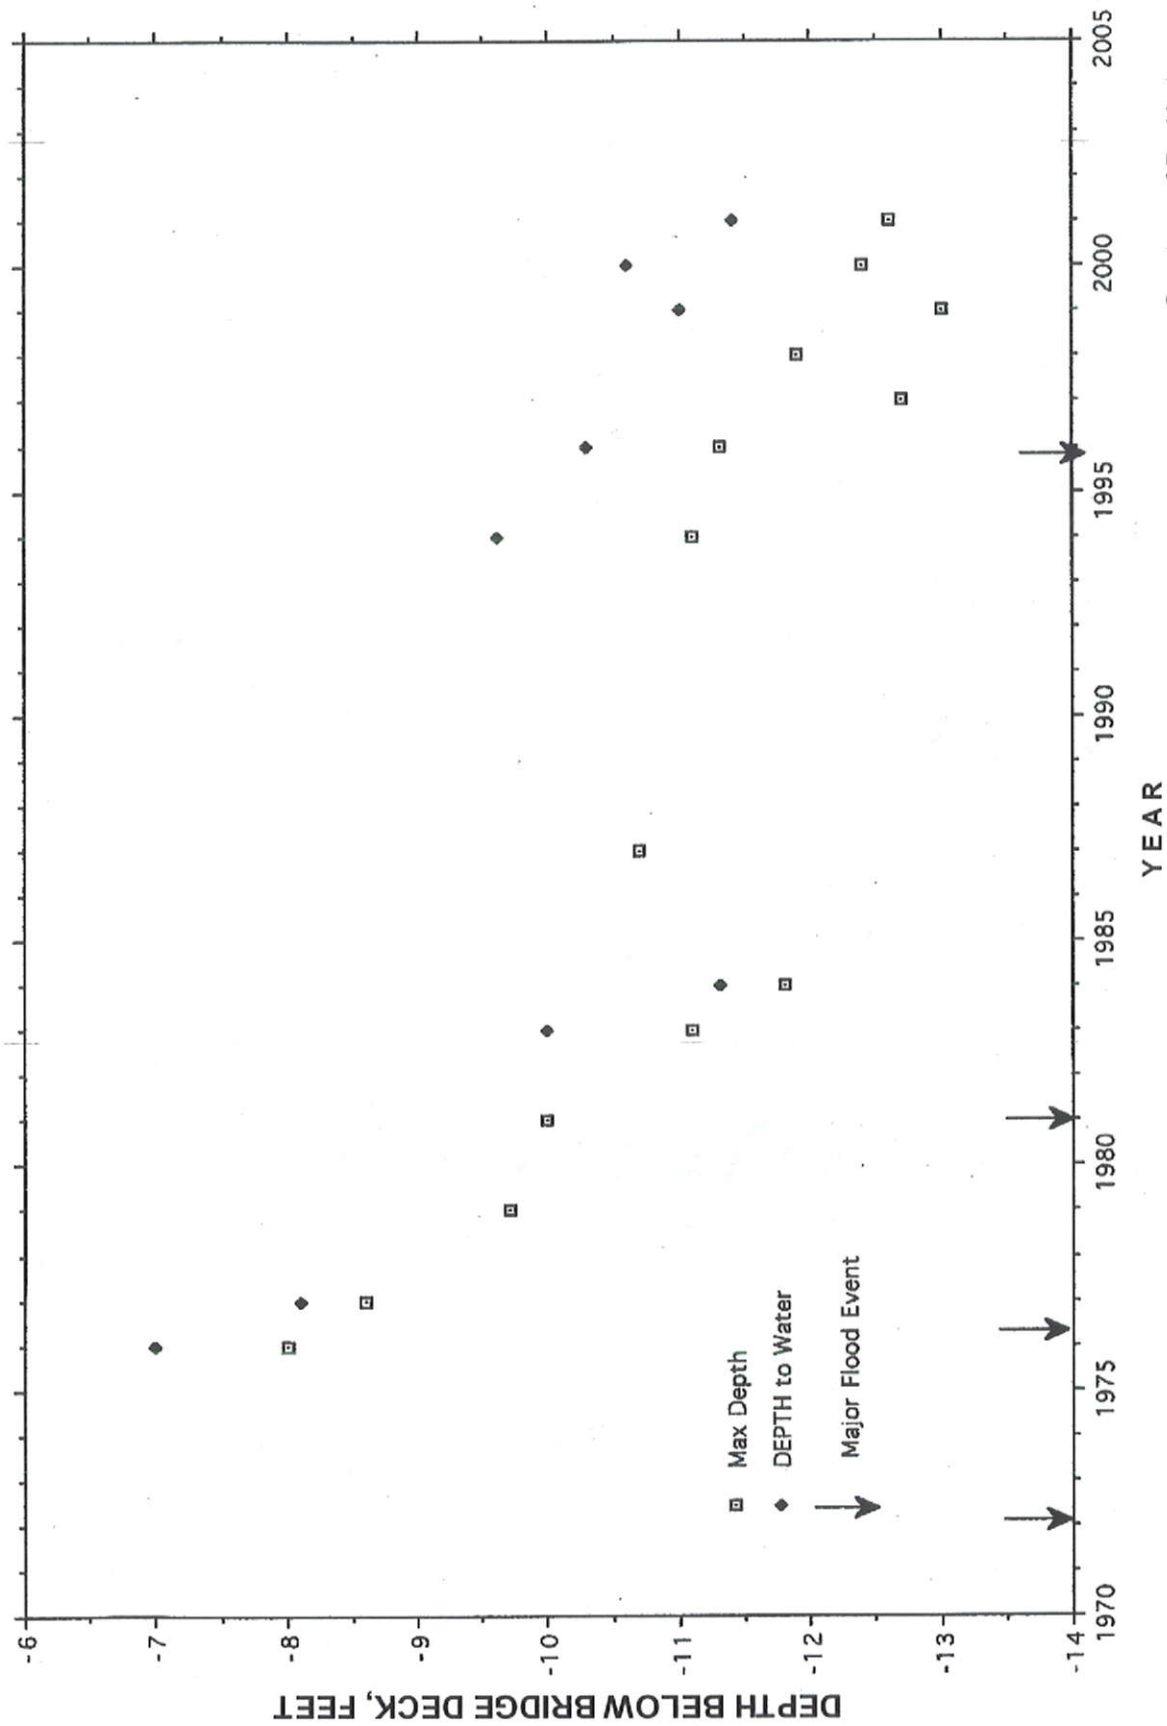
FIGURE 5-1

**SIX MILE CREEK AT GERMAN CROSS ROAD
DEPTH OF CHANNEL BELOW BRIDGE DECK**

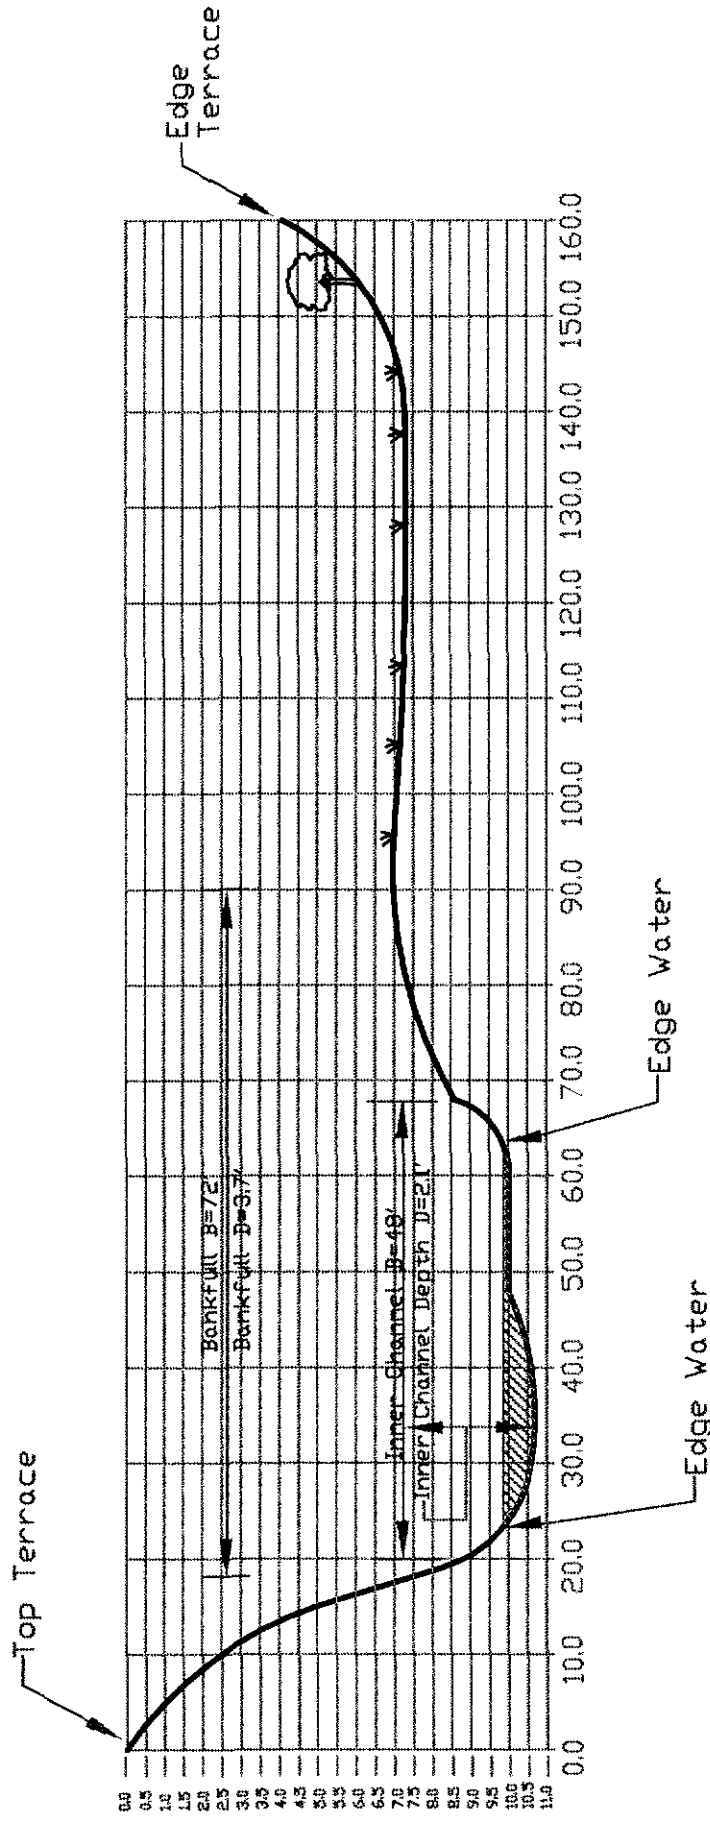
Figure 5-2

**Karlo Property
v/s German Crossroad**

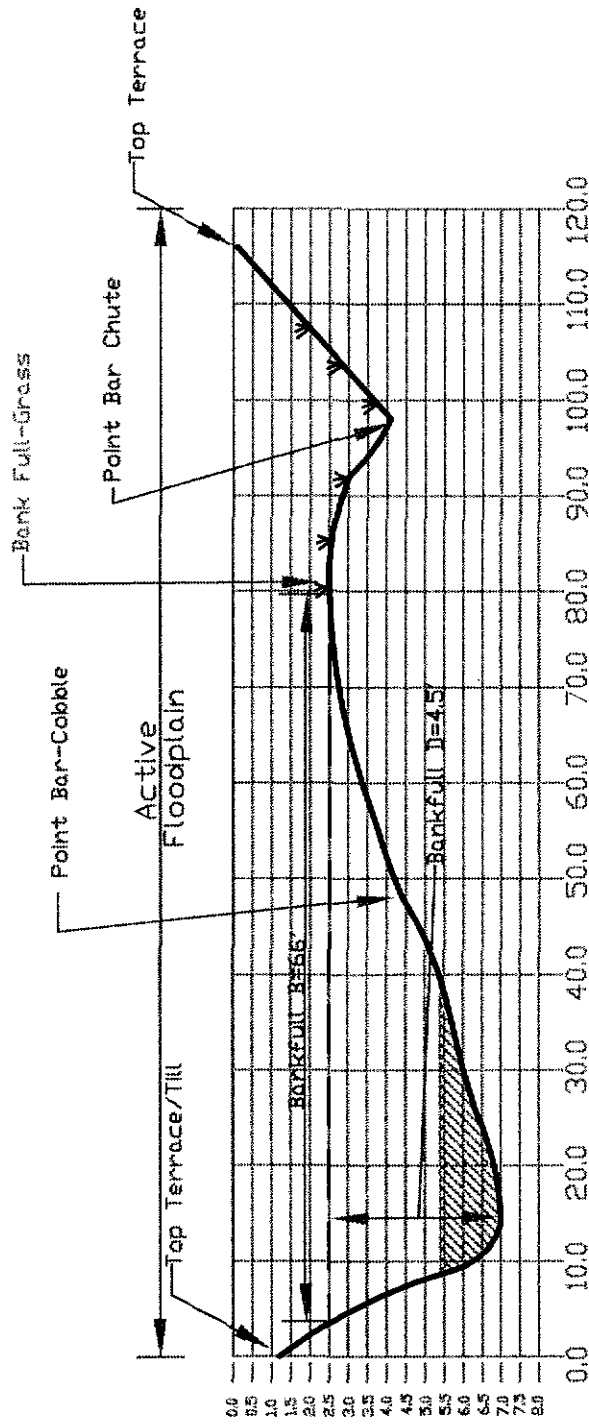
DATE: 8/8/03	H: 1" = 20'	SHEET: 1
SCALE: V: 1" = 5'	Figure 5-3

Bend Cross Section Karla Property

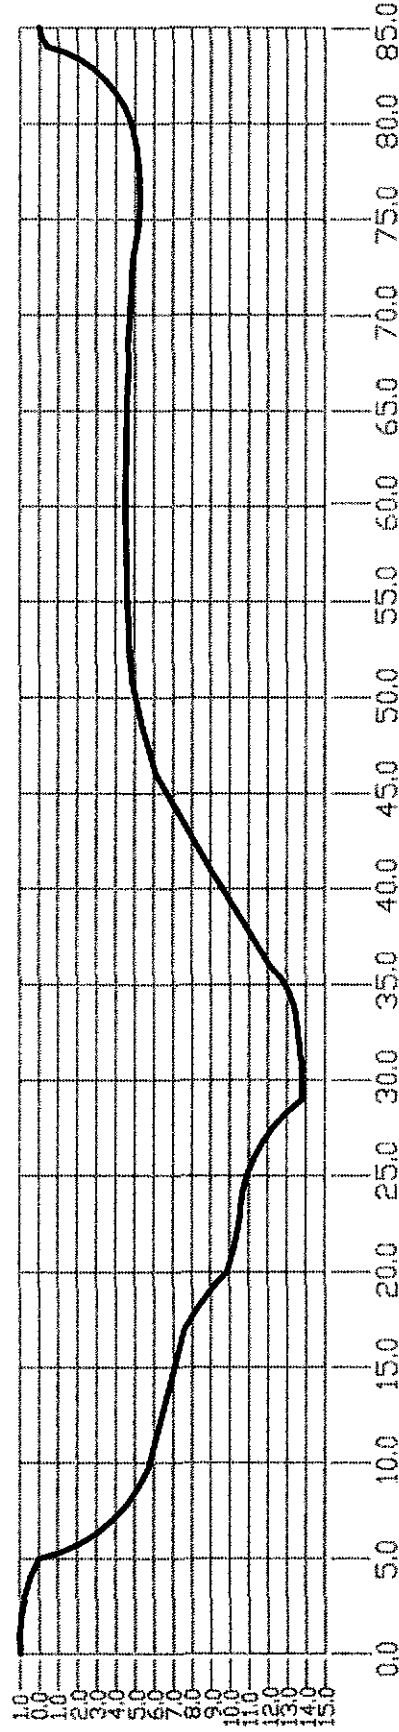
SHEET:
Figure 5-4

Gully Cross Sections
Karlg Property

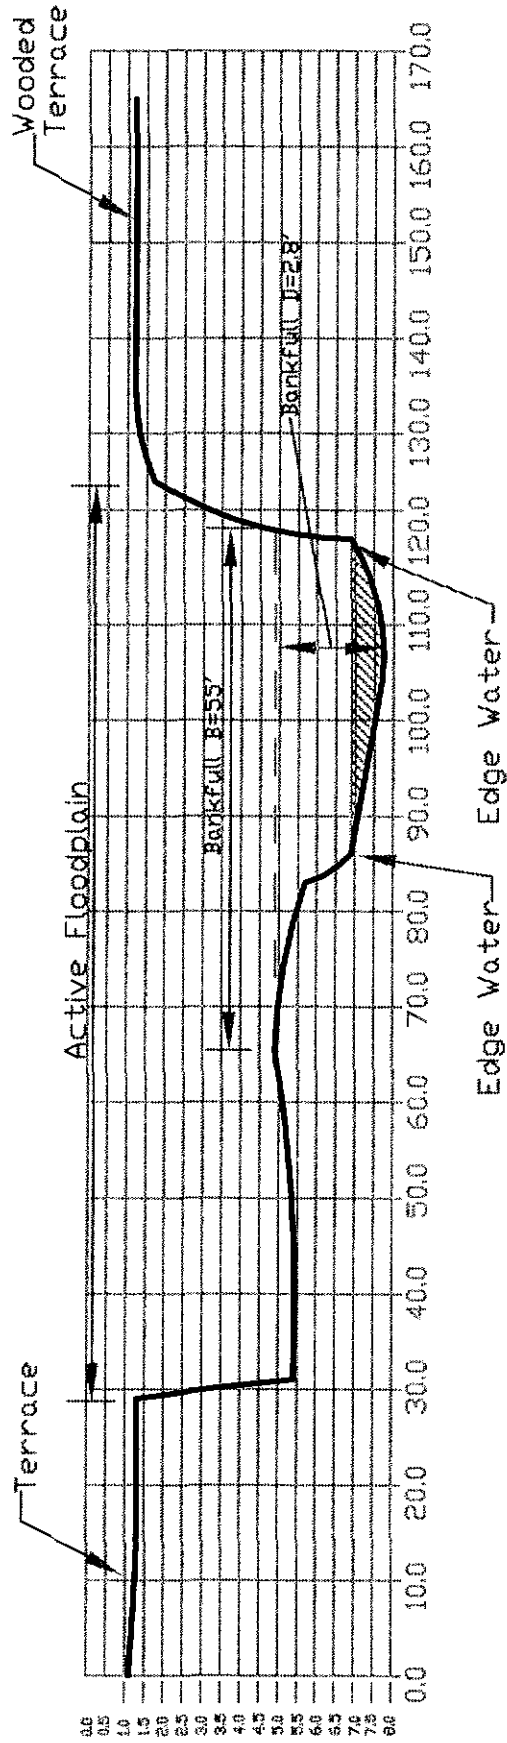
SHEET:
Figure 5-5

River Cross Section **165 ft D/S Banks Road**

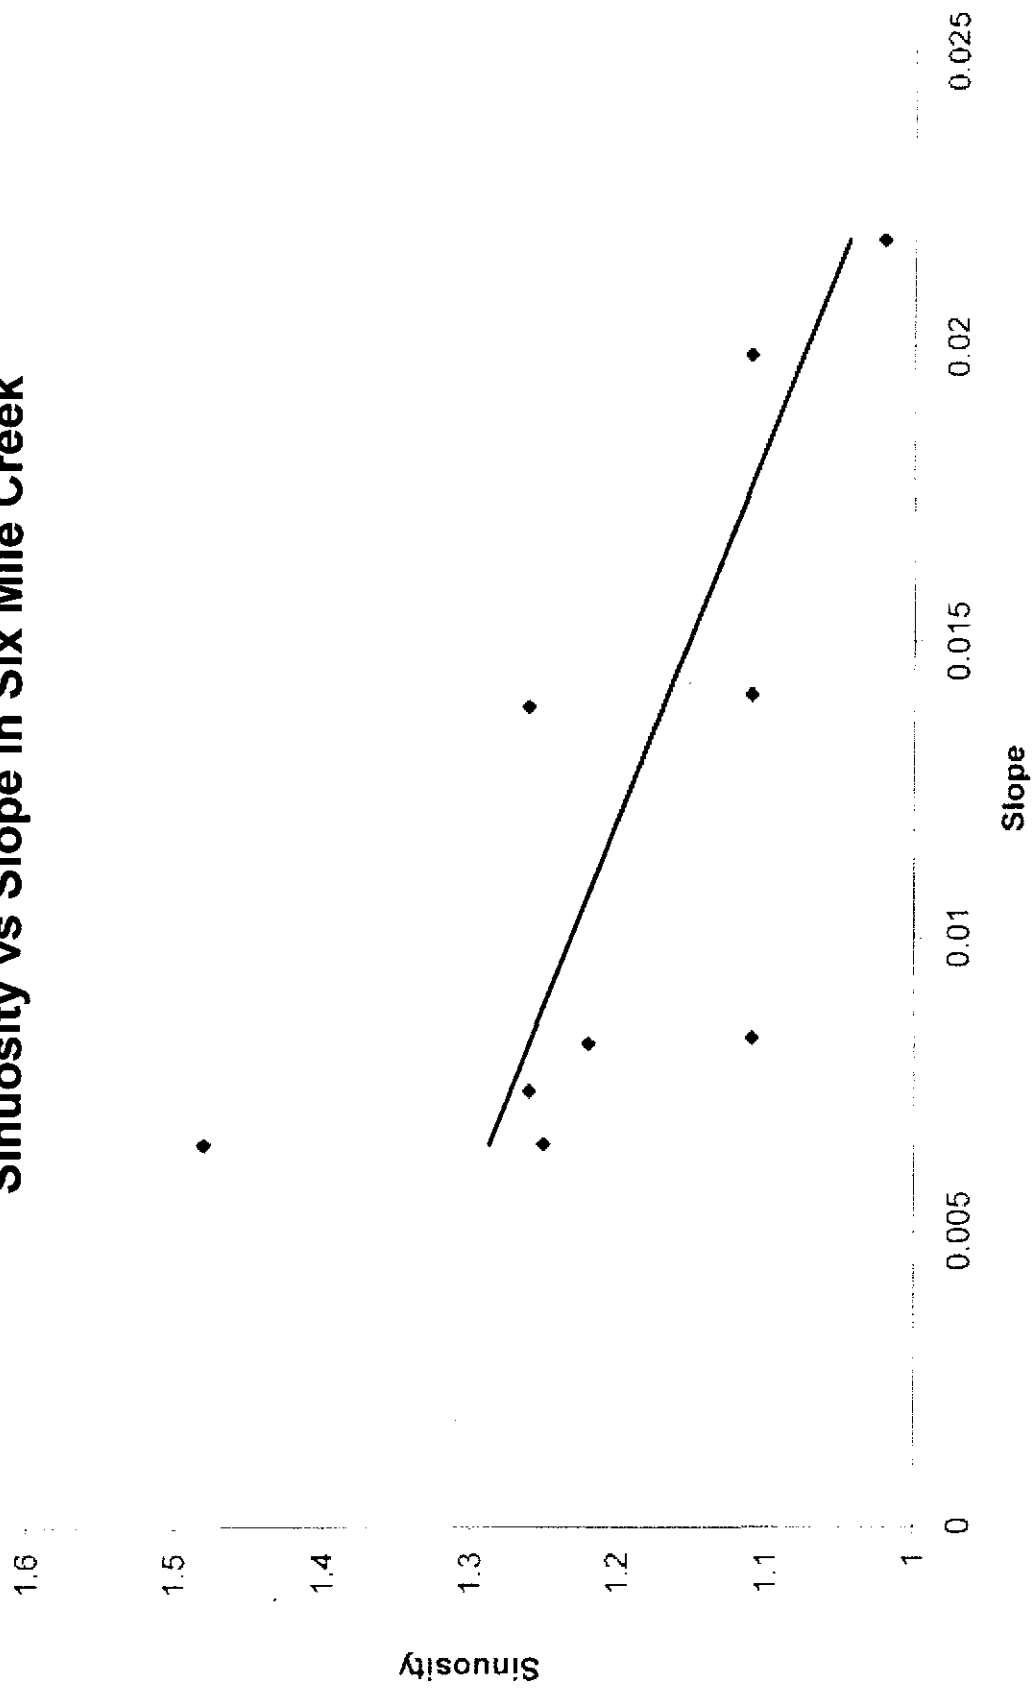
FIGURE 5 – 7
Sinuosity vs Slope in Six Mile Creek

Segment 2 has deep bedrock gorges with steep sides subject to landslides, with three dams forming impoundments. The bedrock and dams control the elevation of upstream segments. Segments 3, 4, and 5 are related to the bedrock control in Segment 2, and show a classic increase in slope in the upstream direction, with a decrease in sinuosity.
